Envelope Sealing Performed For:

Augusta, WI 54722		AEROBARRIER CASE ID: 8246 HARDWARE: AeroBarrier Connect TECHNICIAN: Roland
DATE: 10/22/2021	BUILDING TYPE: Apartment

Envelope Sealing Results:

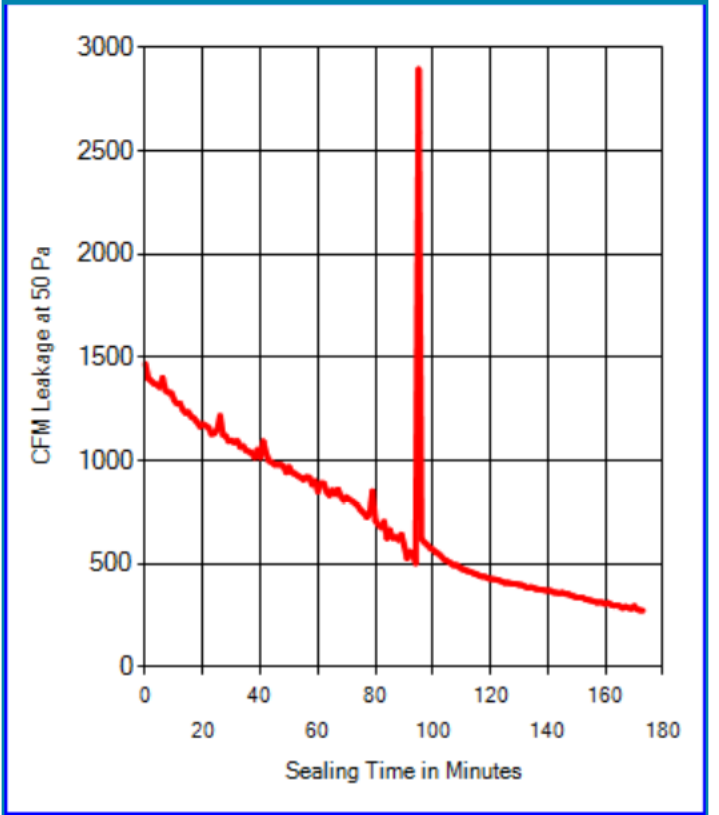
Envelope Sealing Progress:

<h3><u>BEFORE</u> SERVICE</h3> <p>1468.3 CFM of Leakage, equivalent to a 176.8 Square Inch Hole, or 9.37 Air Changes per Hour</p> <p><small>(for your 1175 square-foot structure enclosing a volume of 9400 cubic feet)</small></p>
<h3><u>AFTER</u> SERVICE</h3> <p>271.9 CFM of Leakage, equivalent to a 32.7 Square Inch Hole, or 1.74 Air Changes per Hour</p>
<p>This corresponds to a 81.5% Reduction in Envelope Leakage</p>
<p>NOTE: Envelope leakage and air-change results are calculated at a standard pressure of 50 Pa.</p>

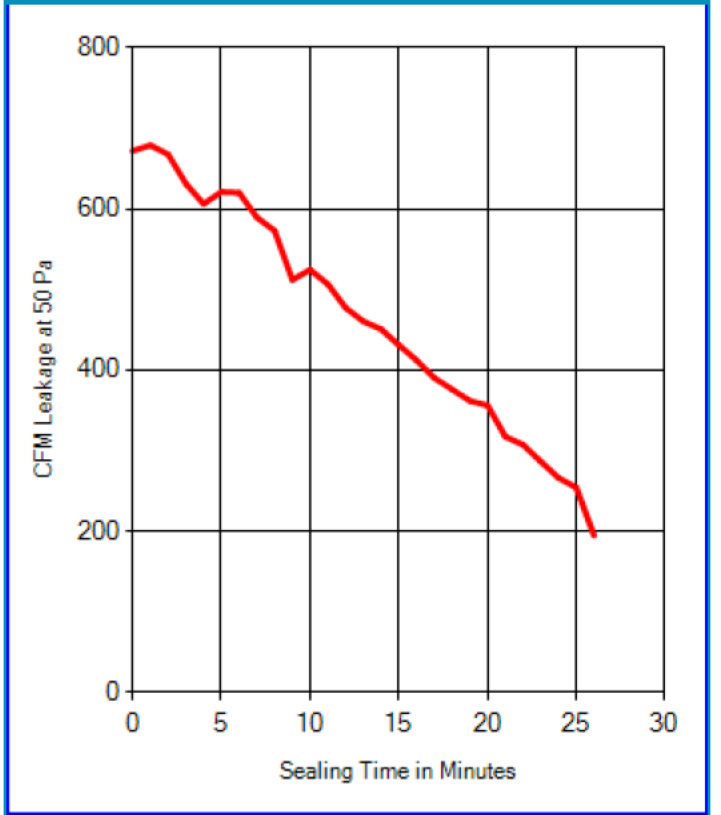
Envelope Sealing Progress:

<p><u>BEFORE</u> SERVICE</p> <p>672.0 CFM of Leakage, equivalent to a 80.9 Square Inch Hole, or 3.21 Air Changes per Hour</p> <p>(for your 1470 square-foot structure enclosing a volume of 12554 cubic feet)</p>
<p><u>AFTER</u> SERVICE</p> <p>194.6 CFM of Leakage, equivalent to a 23.4 Square Inch Hole, or 0.93 Air Changes per Hour</p>
<p>This corresponds to a 71.0% Reduction in Envelope Leakage</p>
<p>NOTE: Envelope leakage and air-change results are calculated at a standard pressure of 50 Pa.</p>
